# Rhapsody J/30 348

Starboard Stanchion Base Repair

May 2006

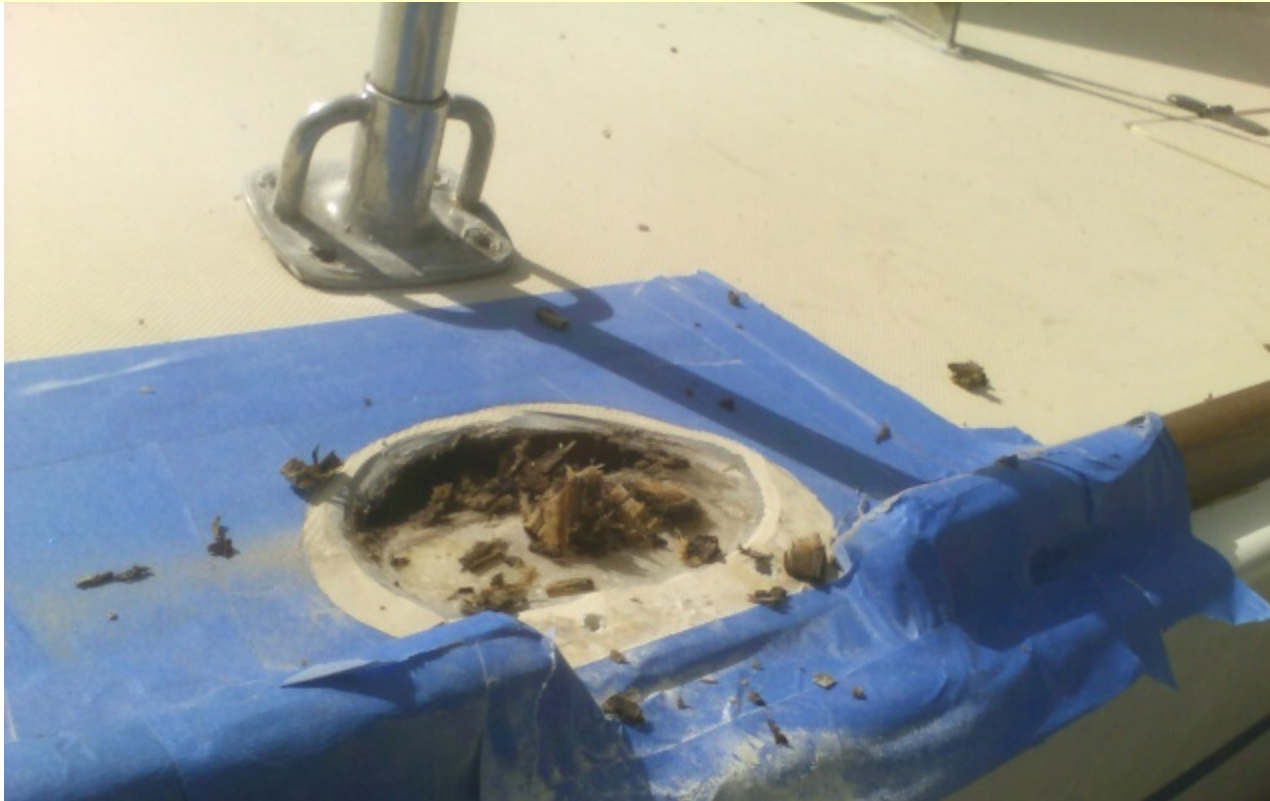
The stanchion was unbolted and rotated away from the work area with lifelines attached.

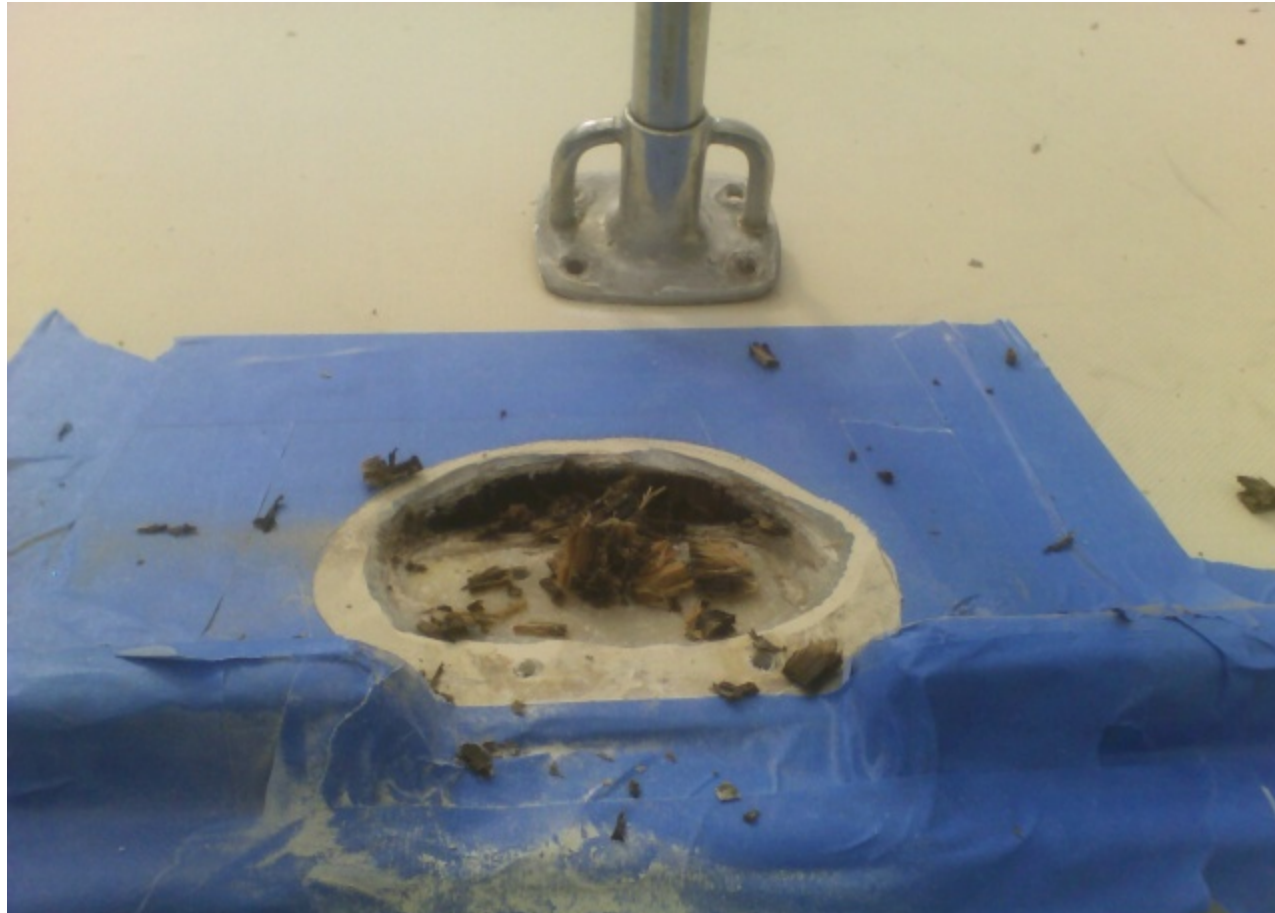
A flat 4" grinding disk was used to cut through gelcoat & fiberglass. Wet core was exposed with the consistency of a saturated sponge.

The area around the cracked base was masked with about a 1 inch buffer zone so that grinding could be done with minimal damage to the surrounding area. After grinding the tape was cut with a knife blade for a smooth transition.
